**Flood Control Project Maintenance
Levee Inspections****LMA District Cover Sheet****Spring 2014 Levee Inspection Results****Reclamation District No. 2031 Elliot**

Spring 2014 Levee Inspection Results

Reclamation District No. 2031 Elliot

Waterway			Bank	Unit Miles
Unit No. 01 Stanislaus River			Left	7.15
	Spring (March - May)	Summer (June - August)	(September - November) Fall	Winter (December - February)
Unit Maintenance Rating (Fall Only)				
Date of Inspection	05/08/2014 - 05/08/2014			
DWR Inspector	Maksim Khashchuk			
Accompanied By	Bob Buckmaster

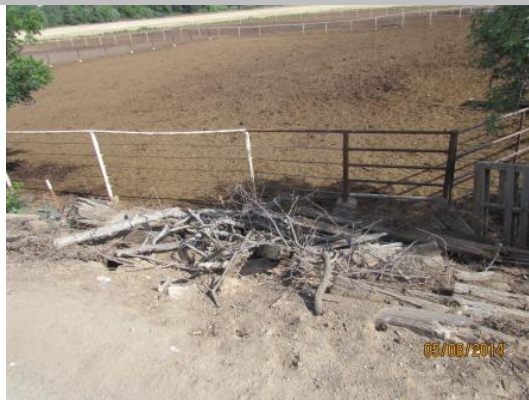
Photo 1 of 1 : mkhashch_s_20140512_01004.jpg

LM Start	0.04	Rating **	U	Issue No.	122
LM End	0.04	Issue Type +	En	Location *	WS
Category	Earthen Levee			GPS Latitude/Longitude	
				Start	End
Item	Encroachments			37.710016 °	37.710016 °
				-121.155803 °	-121.155803 °
DWR ID	DWR_RD2031_01_s _ 2014_122				
Action/Comments					
Debris

View of the pipe of debris on the waterside levee slope.

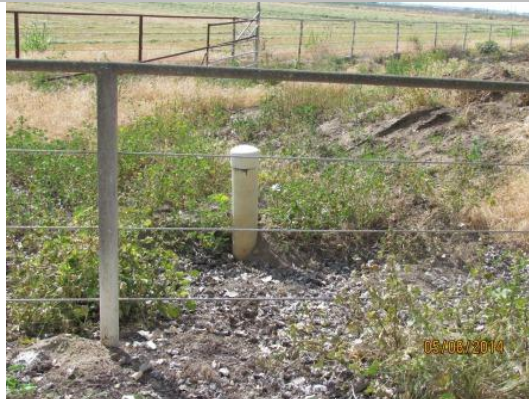
Photo 1 of 1 : mkhashch_s_20140512_01006.jpg

LM Start	0.47	Rating **	M	Issue No.	125
LM End	0.47	Issue Type +	En	Location *	LS
Category	Earthen Levee			GPS Latitude/Longitude	
				Start	End
Item	Encroachments			37.704537 °	37.704537 °
				-121.159041 °	-121.159041 °
DWR ID	DWR_RD2031_01_s _ 2014_125				
Action/Comments					
Pipe					
Inspector Comments: PVC Standpipe at landside levee toe.

View of the PVC standpipe at the landside levee toe.

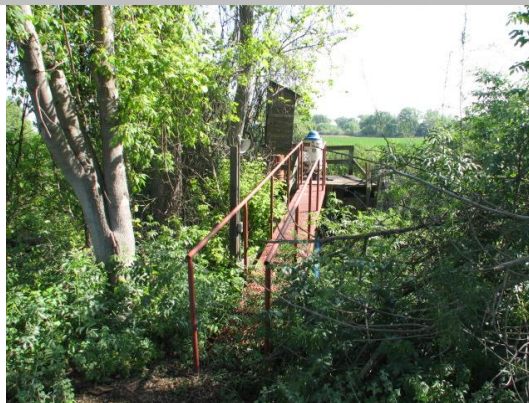
Photo 1 of 1 : mkhashch_s_20140428_00399.jpg

LM Start	1.27	Rating **	A/W	Issue No.	11
LM End	1.27	Issue Type +	Ma	Location *	WS
Category	Earthen Levee			GPS Latitude/Longitude	
				Start	End
Item	Encroachments			37.699536 °	37.699536 °
				-121.169924 °	-121.169924 °
DWR ID	DWR_RD2031_01_s _ 2012_11				
Action/Comments					
Pipe Inspector Comments: Irrigation intake pipe.

Irrigation intake pump and pipe.

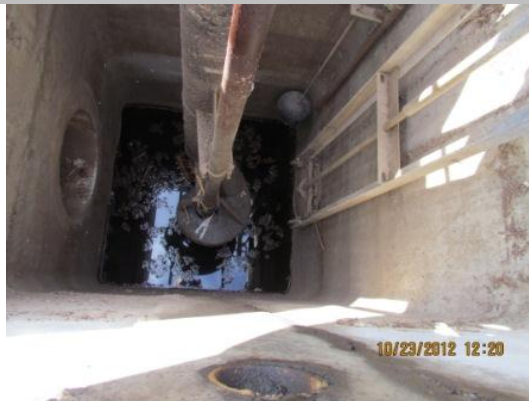
Photo 1 of 3 : mkhashch_s_20140428_00415.jpg

LM Start	2.41	Rating **	A/W	Issue No.	42
LM End	2.41	Issue Type +	En	Location *	LS
Category	Earthen Levee			GPS Latitude/Longitude	
				Start	End
Item	Encroachments			37.688623 °	37.688623 °
				-121.179767 °	-121.179767 °
DWR ID	DWR_RD2031_01_f_2012_42				
Action/Comments					
Pipe					
Inspector Comments: Flap gate is closed and appears to be operational.

View of the closed slide gate.

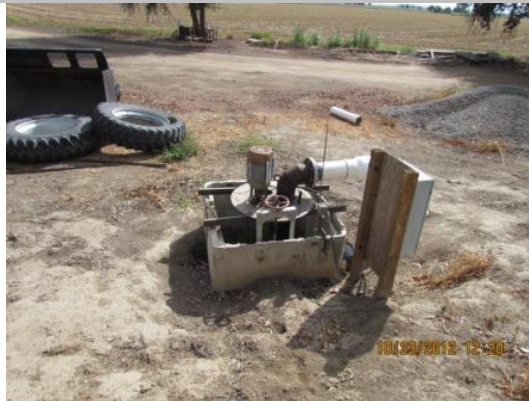
Photo 2 of 3 : mkhashch_s_20140428_00416.jpg

View of the slide gate lever and well.

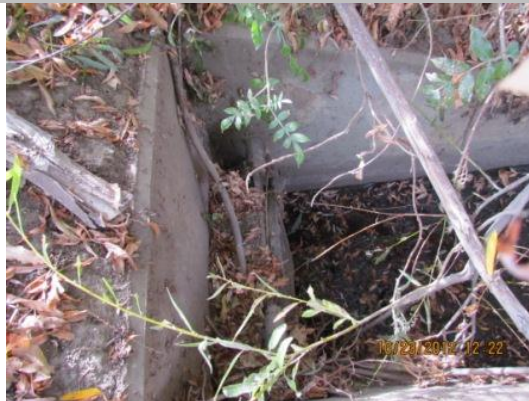
Photo 3 of 3 : mkhashch_s_20140428_00417.jpg

View of closed flap gate on waterside.

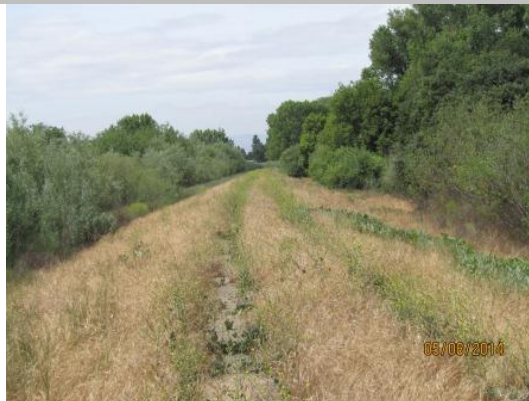
Photo 1 of 1 : mkhashch_s_20140512_01011.jpg

LM Start	4.09	Rating **	M	Issue No.	15
LM End	4.43	Issue Type +	Ma	Location *	CR
Category	Earthen Levee			GPS Latitude/Longitude	
				Start	End
Item	Vegetation			37.690320 °	37.686624 °
				-121.204078 °	-121.207816 °
DWR ID	DWR_RD2031_01_s_2014_15				
Action/Comments					
Control annual grass and weeds on the levee slopes and easements. Inspector Comments: Wildlife preserve.

View of the tall vegetation on the levee slopes and crown obstructing visibility and access.

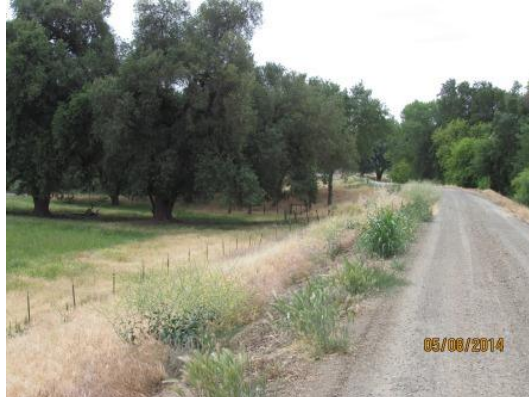
Photo 1 of 1 : mkhashch_s_20140512_01012.jpg

LM Start	0.04	Rating **	M	Issue No.	54
LM End	0.50	Issue Type +	Ma	Location *	LS
Category	Earthen Levee			GPS Latitude/Longitude	
				Start	End
Item	Vegetation			37.661283 °	37.655304 °
				-121.233382 °	-121.233735 °
DWR ID	DWR_RD2031_02_s _ 2014_54				
Action/Comments					
Control annual grass and weeds on the levee slopes and easements.

View of the tall vegetation on the landside levee slope.

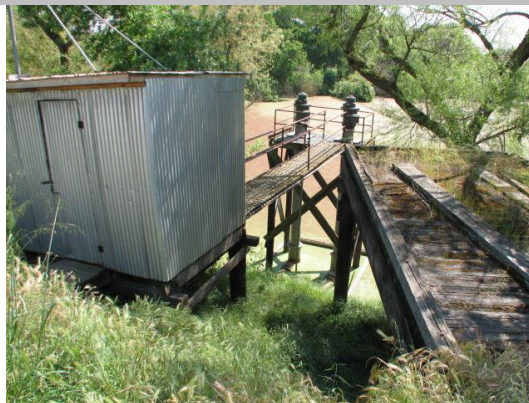
Photo 1 of 2 : mkhashch_s_20140428_00538.jpg

LM Start	0.22	Rating **	A/W	Issue No.	3
LM End	0.22	Issue Type +	En	Location *	LS
Category	Earthen Levee			GPS Latitude/Longitude	
				Start	End
Item	Encroachments			37.658843 °	37.658843 °
				-121.234271 °	-121.234271 °
DWR ID	DWR_RD2031_02_s _ 2012_3				
Action/Comments					
Pipe

Drainage discharge pumps and housing on steep waterside slope.

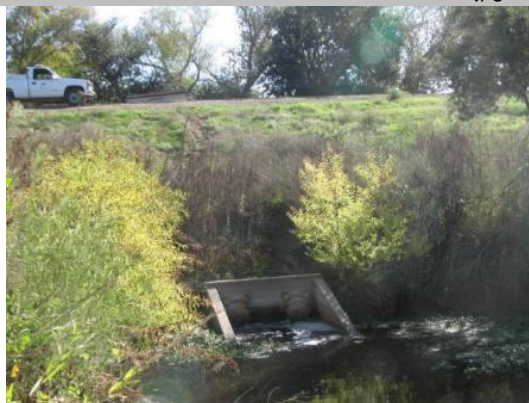
Photo 2 of 2 : mkhashch_s_20140428_00539.jpg

10/26/2011 Flap gates on landside.

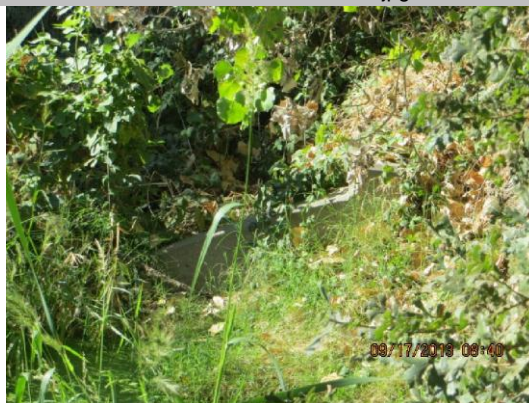
Photo 1 of 1 : UCIP_2277.jpg

LM Start	0.24	Rating **	M	Issue No.	46
LM End	0.24	Issue Type +	En	Location *	LS
Category	Supplemental			GPS Latitude/Longitude	
				Start	End
Item	DWR UCIP Field Study			37.658595 °	37.658595 °
				-121.234410 °	-121.234410 °
DWR ID	DWR_RD2031_02_s _ 2014_46				
Action/Comments					
Inspector Comments: FS_ID:20708

Concrete headwall on LS toe at edge of pond.

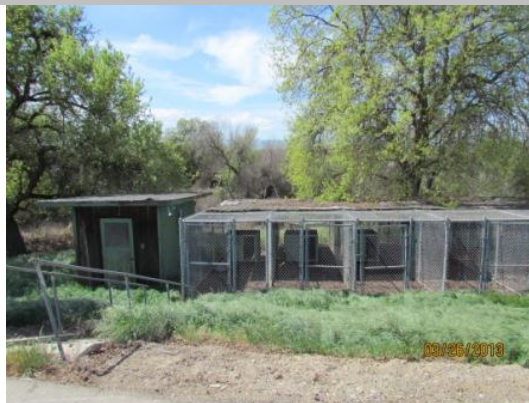
Photo 1 of 1 : mkhashch_s_20140428_00541.jpg

LM Start	1.28	Rating **	M	Issue No.	8
LM End	1.28	Issue Type +	En	Location *	WS
Category	Earthen Levee			GPS Latitude/Longitude	
				Start	End
Item	Encroachments			37.649918 °	37.649918 °
				-121.221913 °	-121.221913 °
DWR ID	DWR_RD2031_02_s _ 2013_8				
Action/Comments					
Building

View of the structure at the waterside levee toe.

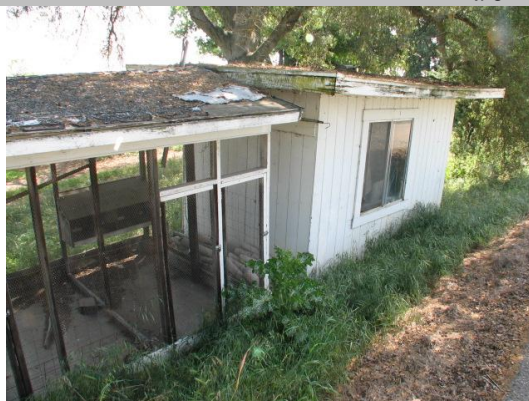
Photo 1 of 1 : mkhashch_s_20140428_00540.jpg

LM Start	1.36	Rating **	U	Issue No.	4
LM End	1.36	Issue Type +	En	Location *	LS
Category	Earthen Levee			GPS Latitude/Longitude	
				Start	End
Item	Encroachments			37.648898 °	37.648898 °
				-121.221621 °	-121.221621 °
DWR ID	DWR_RD2031_02_s _ 2012_4				
Action/Comments					
Building

Small structure on levee slope.

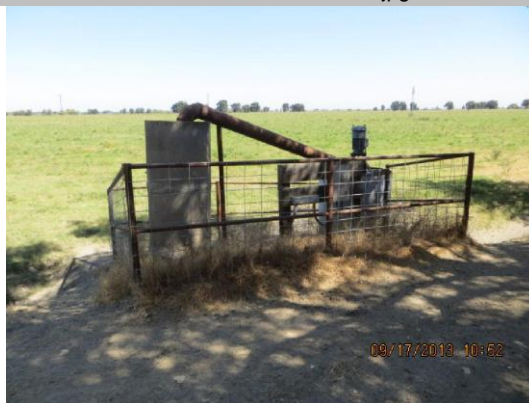
Photo 1 of 1 : UCIP_2282.jpg

Pump sitting atop a 48-inch steep pipe off LS toe. Discharges into concrete riser likely connected to stormdrain pipe.

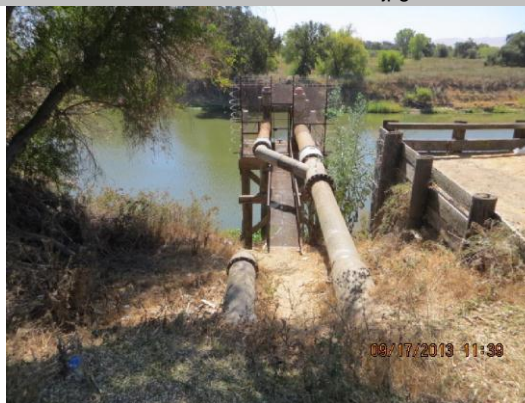
Photo 1 of 1 : UCIP_2290.jpg

LM Start	3.24	Rating **	M	Issue No.	48
LM End	3.24	Issue Type +	En	Location *	LS
Category	Supplemental			GPS Latitude/Longitude	
				Start	End
Item	DWR UCIP Field Study			37.638185 °	37.638185 °
				-121.202906 °	-121.202906 °
DWR ID	DWR_RD2031_02_s _ 2014_48				
Action/Comments					
Inspector Comments: FS_ID:20719					
EP_NO: N/A					
Repair Type:					
Crossing Status:					
UCIP Comments: Annular space between 20-inch and 24-inch pipe not grouted.					
FIELD_STRUCT_DESC: 24-inch steel pipe through levee 8.0 feet below crown. Pump on pile structure in river. 20-inch steel pipe sleeved through 24-inch. 4'X11' concrete distribution box on LS toe. 2-inch electrical conduit at same location. Originally included in the 1968 O&M manual.					
FS Date: 9/17/2013

Pump on pier at WS.

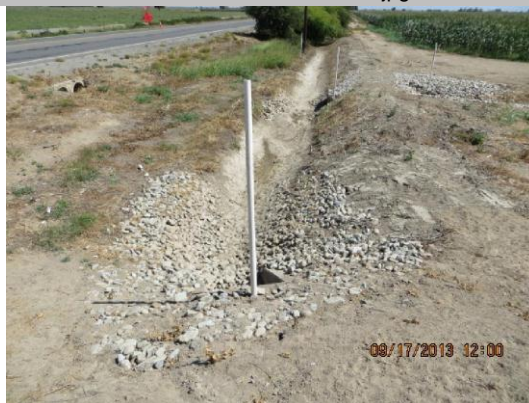
Photo 1 of 1 : UCIP_2293.jpg

LM Start	3.88	Rating **	M	Issue No.	50
LM End	3.88	Issue Type +	En	Location *	LS
Category	Supplemental			GPS Latitude/Longitude	
				Start	End
Item	DWR UCIP Field Study			37.637924 °	37.637924 °
				-121.191600 °	-121.191600 °
DWR ID	DWR_RD2031_02_s_2014_50				
Action/Comments					
Inspector Comments: FS_ID:20726					
EP_NO: N/A					
Repair Type:					
Crossing Status:					
UCIP Comments: Minor debris blocking closure of flapgate on WS toe.					
FIELD_STRUCT_DESC: 24-inch corrugated metal pipe through levee					
11.0 feet below crown. Concrete "U" headwall on each end. Flap gate					
on the waterward end. Originally included in the 1968 O&M manual.					
FS Date: 9/17/2013

Concrete headwall on LS toe.

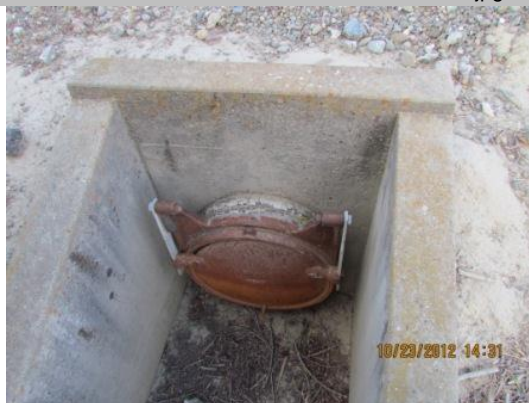
Photo 1 of 1 : mkhashch_s_20140428_00547.jpg

Pipe
Inspector Comments: 36" discharge pipe through the levee with flap gate closed.

View of the closed flap gate on waterside.

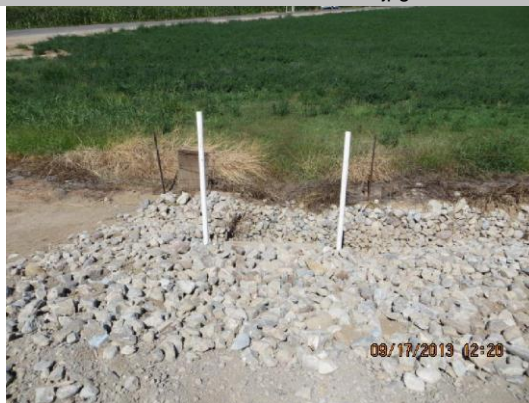
Photo 1 of 1 : UCIP_3261.jpg

LM Start	4.75	Rating **	M	Issue No.	51
LM End	4.75	Issue Type +	En	Location *	WS
Category	Supplemental			GPS Latitude/Longitude	
				Start	End
Item	DWR UCIP Field Study			37.630815 °	37.630815 °
				-121.182416 °	-121.182416 °
DWR ID	DWR_RD2031_02_s _ 2014_51				
Action/Comments					
Inspector Comments: FS_ID:22872					
EP_NO: N/A					
Repair Type:					
Crossing Status:					
UCIP Comments: No permit identified for this crossing.					
FIELD_STRUCT_DESC: 16-inch PVC irrigation pipe through the levee					
6-feet below the crown. Headwall on LS toe.					
FS Date: 9/17/2013

Concrete headwall at outlet on LS toe.

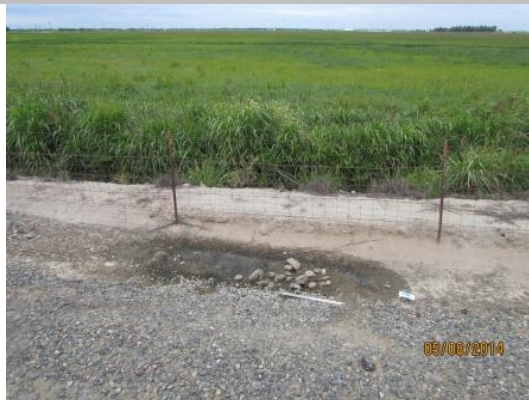
Photo 1 of 1 : mkhashch_s_20140512_01016.jpg

LM Start	5.52	Rating **	U	Issue No.	18
LM End	5.52	Issue Type +	Ma	Location *	LS
Category	Earthen Levee			GPS Latitude/Longitude	
				Start	End
Item	Seepage / Sandboils			37.630802 °	37.630802 °
				-121.168439 °	-121.168439 °
DWR ID	DWR_RD2031_02_s _ 2014_18				
Action/Comments

View of the seepage at the landside levee toe.

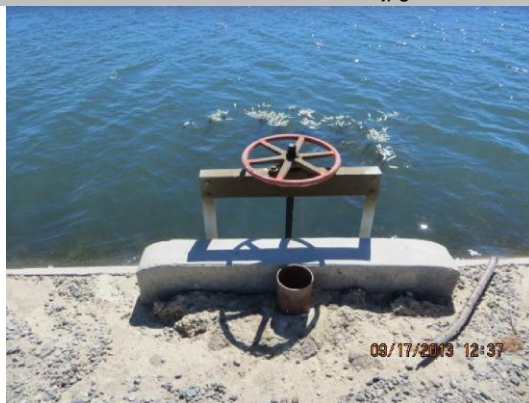
Photo 1 of 1 : UCIP_3262.jpg

LM Start	5.69	Rating **	M	Issue No.	52
LM End	5.69	Issue Type +	En	Location *	LS
Category	Supplemental			GPS Latitude/Longitude	
				Start	End
Item	DWR UCIP Field Study			37.630779 °	37.630779 °
				-121.165402 °	-121.165402 °
DWR ID	DWR_RD2031_02_s_2014_52				
Action/Comments					
Inspector Comments: FS_ID:22873					
EP_NO: N/A					
Repair Type:					
Crossing Status:					
UCIP Comments: No permit identified for this crossing.					
FIELD_STRUCT_DESC: 24-inch PVC irrigation pipeline through levee					
5.0-feet below crown. Slide gate at waterward shoulder. 6-inch steel					
riser on WS shoulder.					
FS Date: 9/17/2013

Slide gate and vent at concrete headwall on canal at WS shoulder.

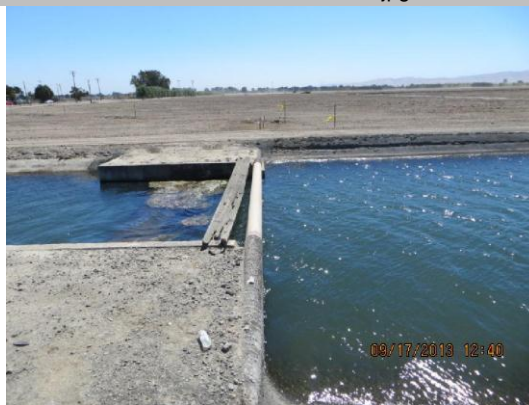
Photo 1 of 1 : UCIP_2321.jpg

LM Start	5.99	Rating **	M	Issue No.	53
LM End	5.99	Issue Type +	En	Location *	LS
Category	Supplemental			GPS Latitude/Longitude	
				Start	End
Item	DWR UCIP Field Study			37.630760 °	37.630760 °
				-121.159951 °	-121.159951 °
DWR ID	DWR_RD2031_02_s_2014_53				
Action/Comments					
Inspector Comments: FS_ID:20745					
EP_NO: N/A					
Repair Type:					
Crossing Status:					
UCIP Comments: Gasline may not have enough cover.					
FIELD_STRUCT_DESC: 8-inch gas line through the levee 1.0-foot					
below the crown. Originally included in the 1968 O&M manual. Sign on					
LS toe, pipe visible at canal.					
FS Date: 9/17/2013

Gasline visible at crossing.
